Navajo Abandoned Uranium Mine

Site Screen Report

Bec068 AUM Site

Navajo AUM Northern Region

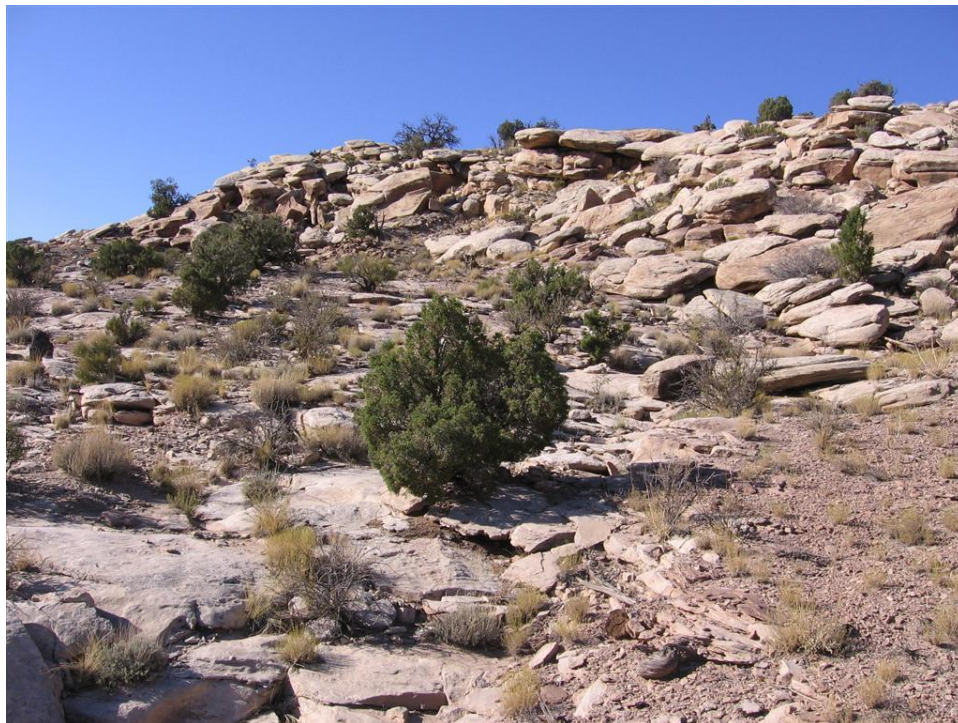
Photo 1. Mine site

Bec068 mine consists of an area of 17,666.51 m². The mine was not identified as ever being operational. No other historical information or any additional ownership / lease information was identified in the EPA/AUM database.

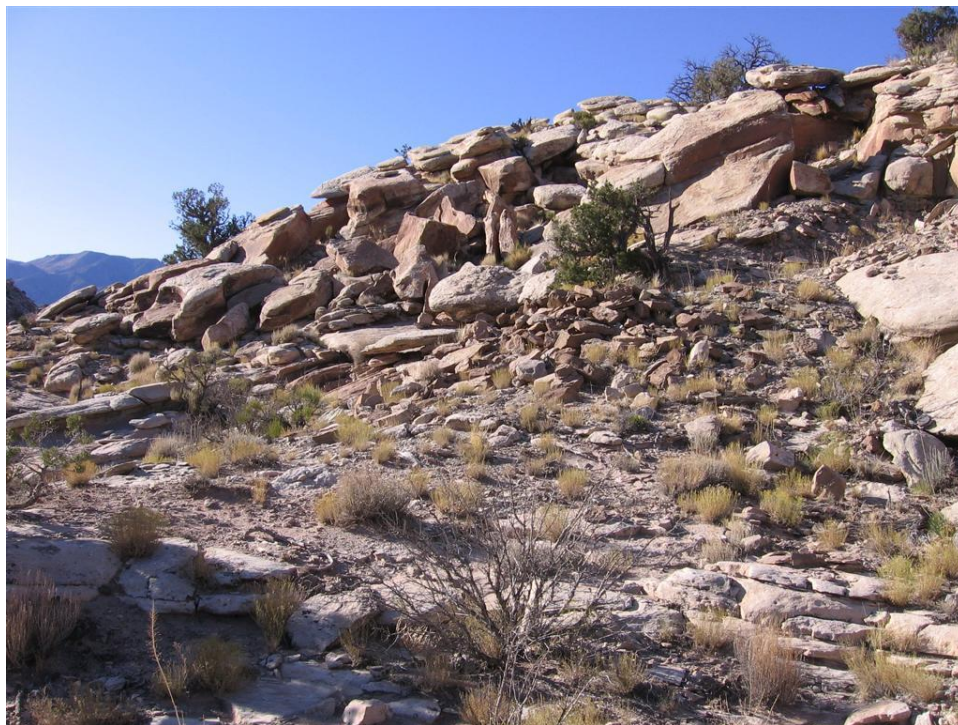
Photo 2. Waste pile

Medium waste pile on northern face, 75' x 75', with a total estimated volume of 1,042 yd³

Unreclaimed waste pile
